GEOTECHNICAL ENGINEERING REPORT

PROPOSED RESIDENCE

2003 82nd AVENUE SE

Project No. 19-012
March 4, 2019

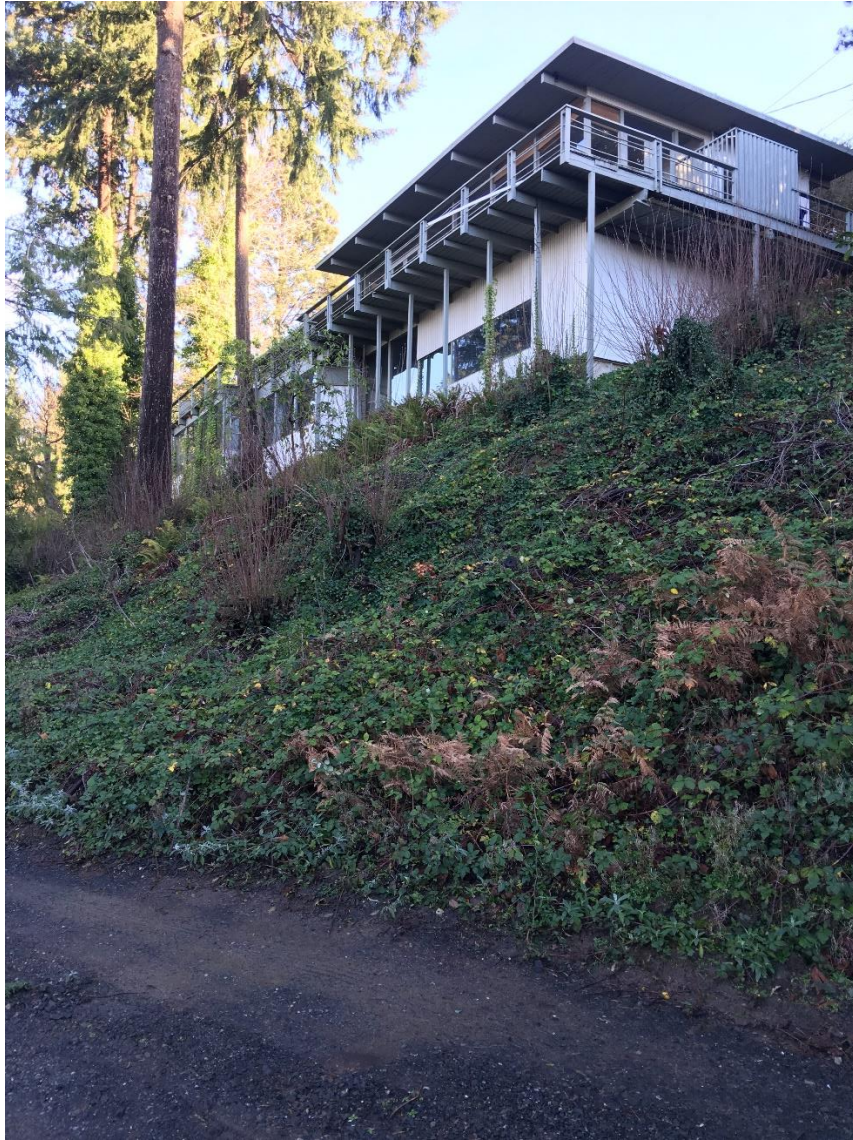
Plate 1. *Looking northeast, near south end of the site, at the general location of the current and proposed residence. (01/04/2019)*

Plate 1 below depicts current site conditions.

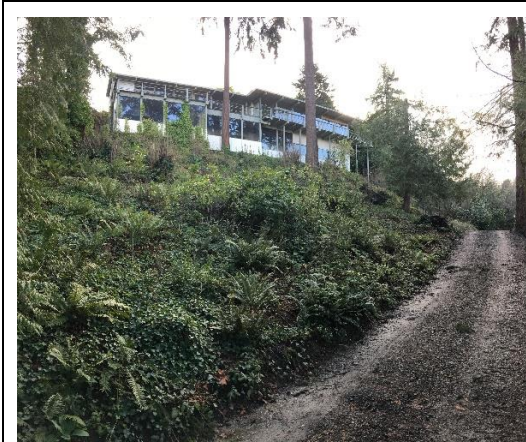
Plate 2. Looking southeast at slope below existing/proposed residence.

We observed the mature trees on the site to have generally straight trunks, and no evidence of significant soil creep was observed. The slopes below the existing residence were uniform in nature, and appeared to slope at an angle of about 2H:1V to 2.5H:1V, which is consistent with our review of the topographic survey. Plates 2 and 3 below depict slope conditions downslope of the existing and proposed developed area.

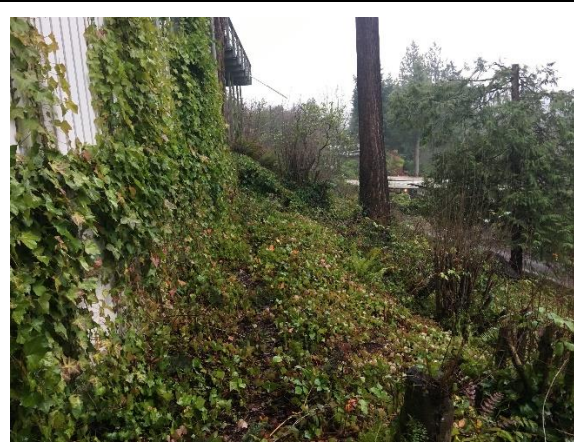
Plate 3. Looking south along west side of house at slope below existing residence.
