# SW 1/4 SECTION 18, TOWNSHIP 24 N, RANGE 5 E, W.M. LORENZINI SP

C1	1 OF 6	TITLE SHEET
C2	2 OF 6	SITE PLAN
C3	3 OF 6	TREE PLAN
C4	4 OF 6	CONCEPTUAL GRADING & UTILITY PL

SITE ADDRESS:	719 86TH AVENUE SE
TAX PARCEL NUMBER:	7598100420
NUMBER OF LOTS:	2
ZONING:	R-9.6
SITE AREA:	28,644 S.F. (0.657 ACR
GROSS PROJECT AREA:	29,138 S.F. (0.669 ACR
PROPOSED GROSS FLOOR AREA:	<i>TBD</i>
PROPOSED IMPERVIOUS AREA:	11,951 S.F. (41.0%)
PROPOSED PERVIOUS AREA:	17,187 S.F. (59.0%)
EXISTING LOT COVERAGE:	9,079 S.F. (31.7%)
PROPOSED LOT COVERAGE:	10,923 S.F. (38.1%)
PROPOSED BUILDING HEIGHT:	<i>TBD</i>

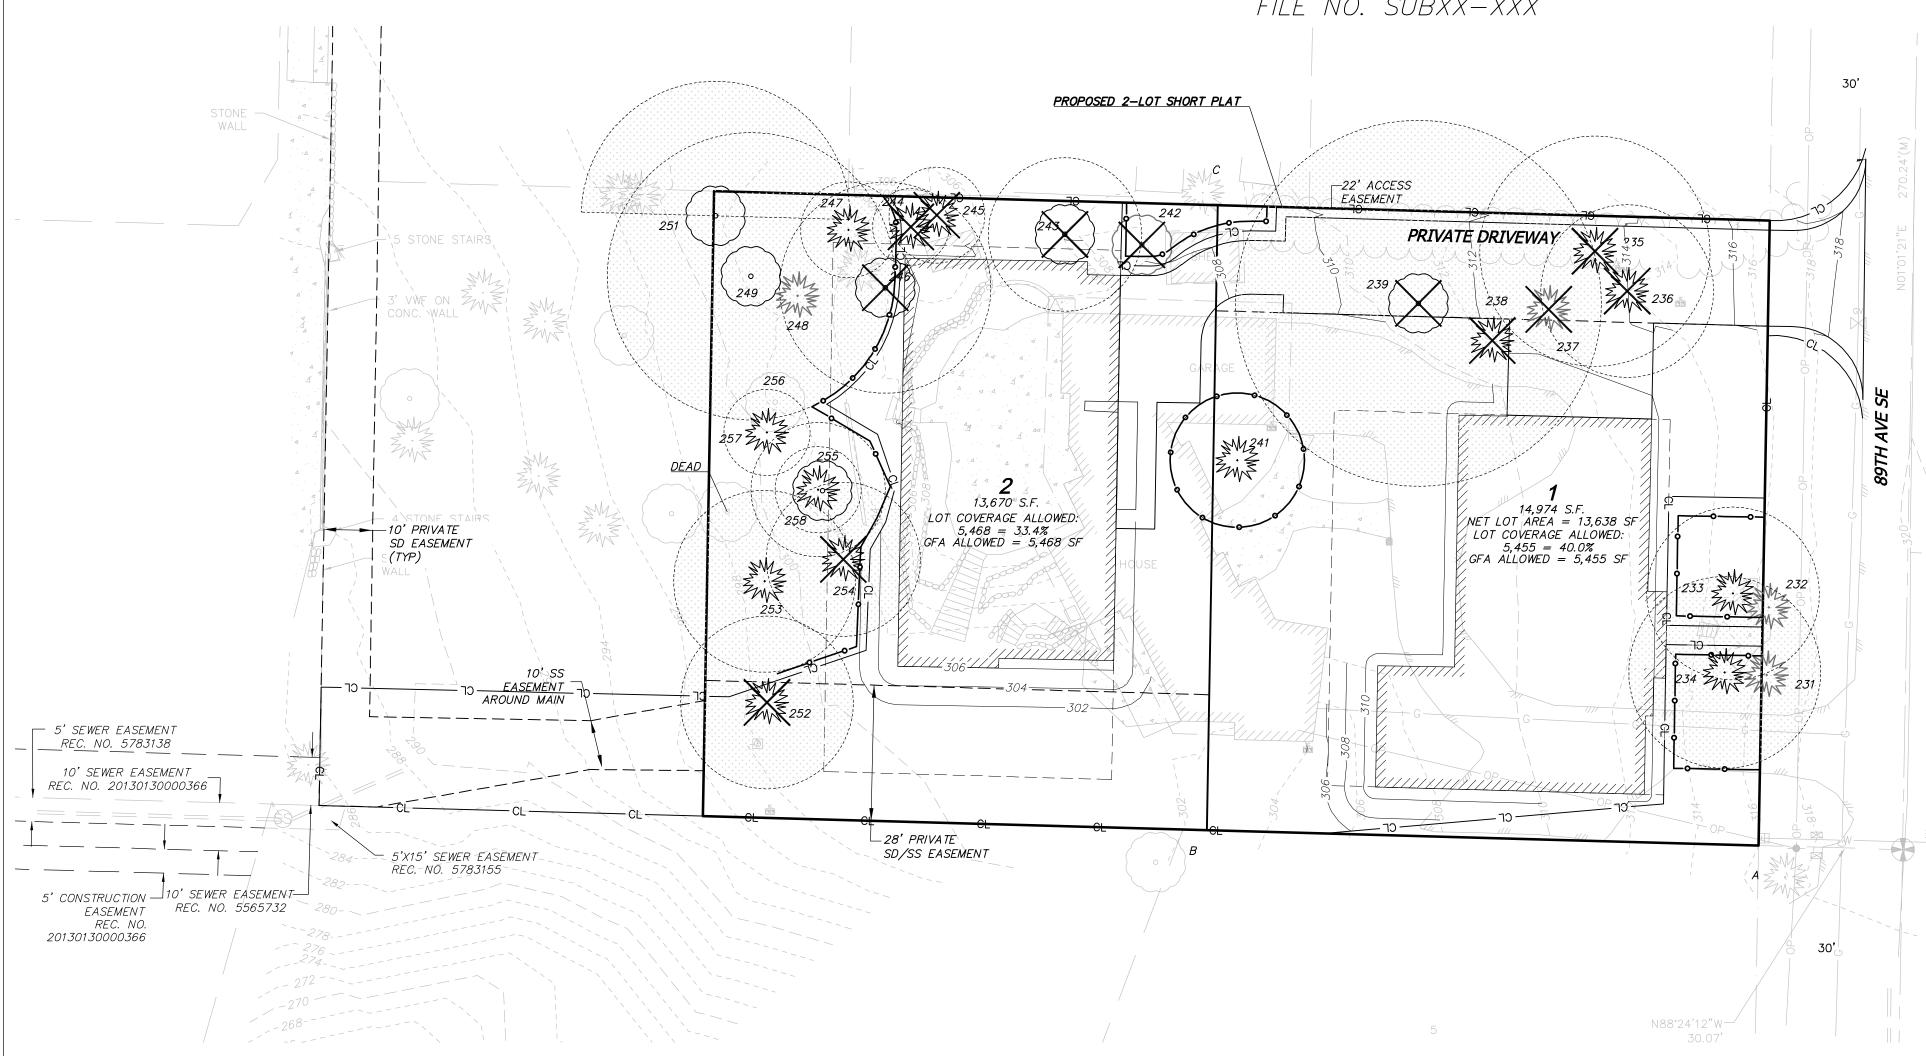
DRAWING: C3 SHEET: **3** OF **4**

#	Tag #	Species ID	DBH (in)	DBH (in)	line radius (ft)		OK in Grove	Health	Defects/Comments	Viable	Remove	N W E S		s	Exceptional t	Value	Healthy Trees		
1	231	Douglas	18	18	20			Poor	Topped @ 22' for power		1	20	20	20	20	N	1		H
2	232	fir Douglas	18	18	18			Poor	Topped @ 22' for utilities		1	18	18	18	18	N	1		H
3	233	fir Douglas	21	21	18			ок		1	_	18	18	18	18	N	1	1	H
		fir Douglas							Typical of species  Self-corrected lean towards west, dead										
4	234	fir	28	28	20			ок	wood, broken branches, dead twigs, typical of species Debris over crown, previous	1		20	20	20	20	Y	1	1	
5	235	Douglas fir	22	22	24			ок	top loss, coning, dead wood, broken branches, typical of species Previous ivy @ root crown	1		24	24	24	24	N	1	1	
6	236	Douglas fir	19	19	18			ок	up to 50', typical of species, asymmetric canopy towards north	1		18	18	18	18	N	1	1	
7	237	Douglas fir	19	19	16			Fair	Self-corrected lean towards north, serpentine trunk, codominant leaders with included bark x2 @ 30' towards north, strong leader, reaction wood, horizontal crack @ 25', column of decay @ root crown up to 12' towards west, 3 calloused wounds towards west, free flowing sap		1	16	16	16	16	N	1	1

8	238	Douglas fir	24	24	18		Y	Fair	Exposed roots, moss and lichen, previous top loss, dead wood, broken branches, elongated	1		18	18	18	18	Y	1	1	
9	239	Bigleaf maple	38	38	38		Υ	Fair	branches Calloused wound @ 6' towards south, exposed roots, decay in roots towards north, dead wood, broken branches, grade lowered 3' towards east	1		38	38	38	38	Y	1	1	f
10	240	Styrax	7	7	14			Good	Typical of species	1		14	14	14	14	N	1	1	‡
11	241	Japonica Scots	13	13	14			ОК	Typical of species	1		14	14	14	14	N	1	1	t
12	242	pine Bigleaf maple	16	16	14			Fair	Vertical crack @ 3' up to 10' towards south, co-dominant leaders with included bark x3 @ 10'	-	1	14	14	14	14	N	1	1	-
13	243	Bigleaf maple	10, 8, 14, 15	24	16			ок	Co-dominant leaders with included bark x4 @ root crown, moss and lichen, typical of species	1		16	16	16	16	Y	1	1	<b> </b>
14	244	White pine	15	15	8			ок	Serpentine trunk, dead wood, broken branches, typical of species	1		8	8	8	8	N	1	1

15	245	White pine	19	19	10			ок	Dead wood, broken branches, a towards east, typical of species <b>Co-dominant leaders</b>	1		10	10	10	10	N	1	1	Ī
16	246	Bigleaf maple	17, 18	25	22			ок	with included bark x2 @ 2', asymmetric canopy towards south, typical of species	1		22	22	22	22	Y	1	1	
17	247	White pine	11	11	10			ок	Suppressed canopy, dead wood, broken branches, typical of species	1		10	10	10	10	N	1	1	+
18	248	Douglas fir	19	19	18			Fair	Epicormic branch formation @ 25' towards south, previous top loss, elongated branches, serpentine trunk, asymmetric canopy towards south		1	18	18	18	18	N	1	1	
19	249	Bigleaf maple	16, 44	47	30		Y	Fair	Co-dominant leaders with included bark x2 @ 4', exposed roots, calloused wound, dead wood, broken branches, asymmetric canopy towards north	1		30	30	30	30	Y	1	1	
20	250	White pine	8	8	10			Poor	Ivy @ root crown up to 30', failing towards east		1	10	10	10	10	N	1		+

21	251	Bigleaf maple	26	26	28 north only			ок	Asymmetric canopy towards north, typical of species, dead wood, moss and lichen	1		28	28	28	28	Y	1	1	
22	252	Douglas fir	28	28	18		Y	Fair	Self-corrected lean towards south, fill over crown, abnormal bark, popping bark, previous top loss, elongated branches, typical of species, dead wood, broken branches  Dead wood, broken	1		18	18	18	18	Y	1	1	
23	253	Douglas fir	36	36	19			ок	branches, previous top loss, carpenter ants bark only Co-dominant leaders with included bark x2 @ 1', previous top loss @	1		19	19	19	19	Y	1	1	
24	254	Douglas fir	36, 28	45.5	16			ок	50', strong laterals, dead wood, broken branches, abnormal bark, popping bark, woodpecker activity Abnormal bark, shedding	1		16	16	16	16	Y	1	1	
	255	Douglas fir	16	16	14		Y	Fair	bark, popping bark, topped @ 50', strong lateral, low live crown ratio <10% Co-dominant leaders	1		14	14	14	14	N	1	1	1

25				1	ı	l	I		with included bark x2 @		١.			26	٦.		١.		
	256	Bigleaf maple	36, 24	43.5	26			Poor	1', dead scaffolds, dead wood, cavity @ 3' towards north		1	26	26	26	26	Y	1		ļ
	<b>256</b>			<b>43.5</b>	<b>26</b>			Poor	wood, cavity @ 3'	1	1	9	9	9	9	N	1	1

TOTAL ONSITE TREES: TOTAL VIABLE ONSITE TREES: TOTAL NUMBER OF EXCEPTIONAL TREES: REQUIRED: 30% VIABLE TREES:	28 21 10 6.3
PROPOSED VIABLE TREES RETAINED:	9/42.8%
OFFSITE TREE	
123 DRIPLINE OF VIABLE TREE	
123 DRIPLINE OF EXCEPTIONAL TREE	
123 NON VIABLE TREE	
123 126 TREE TO BE REMOVED

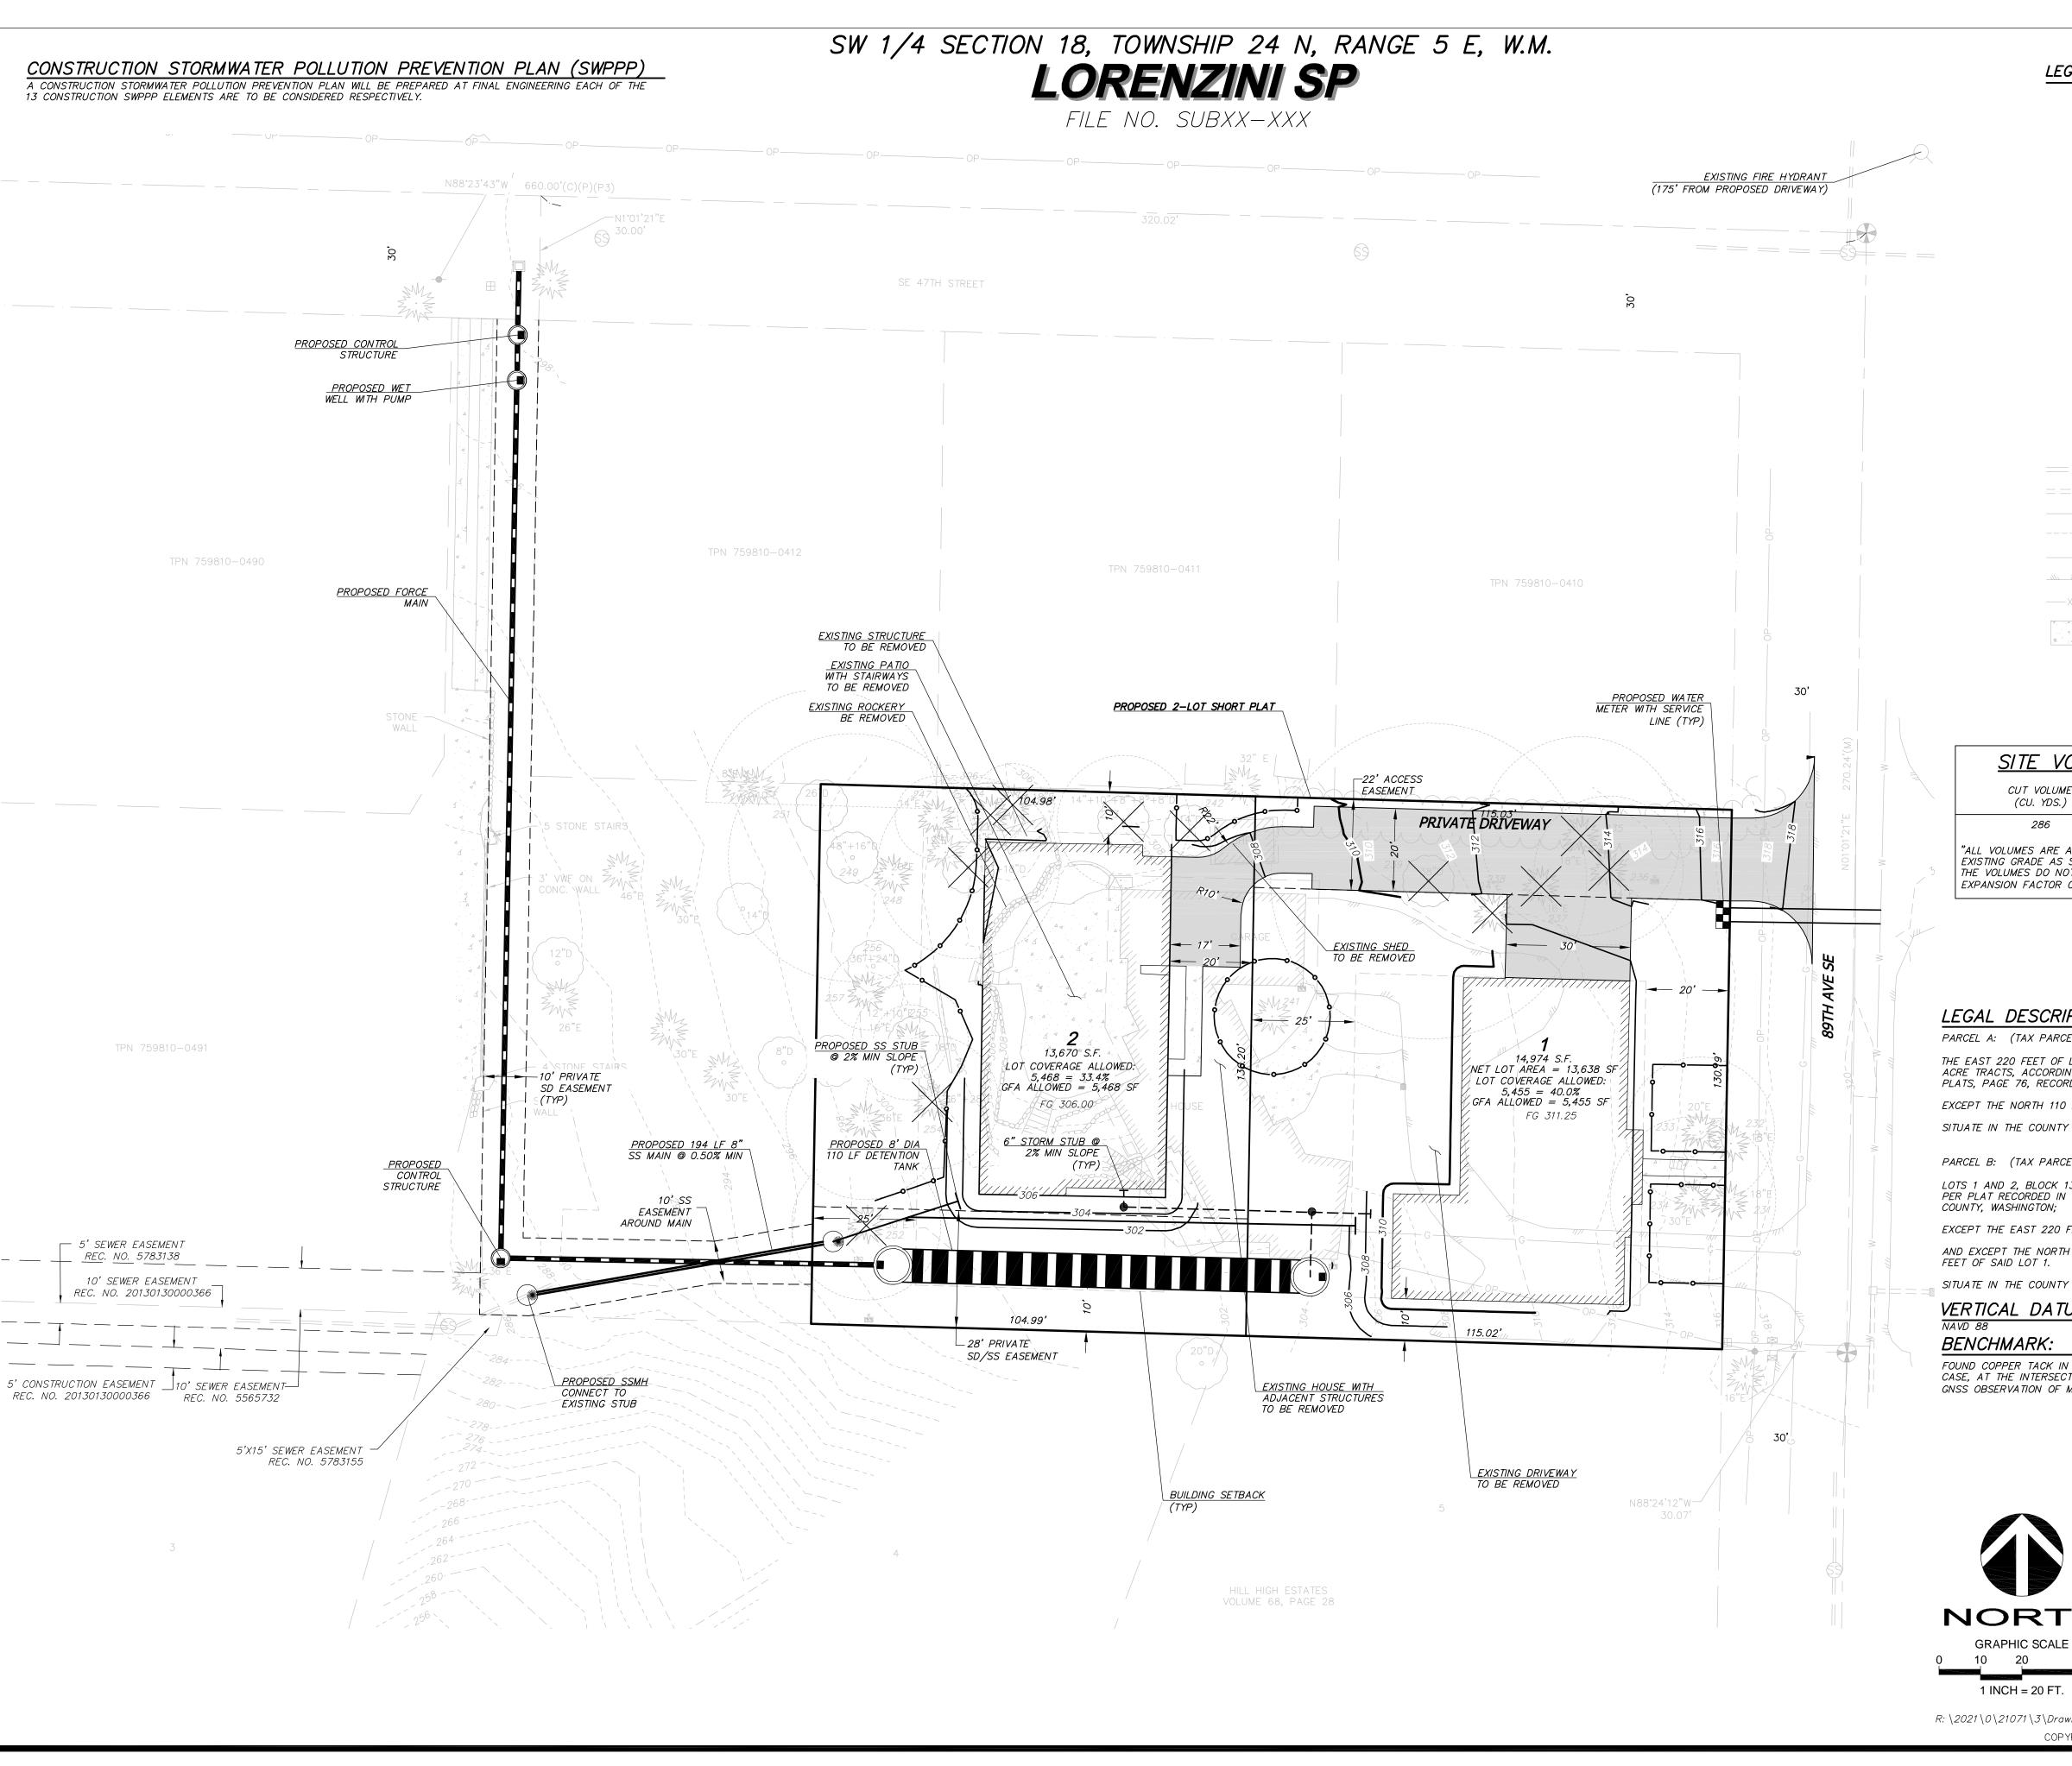
DRAWING: **C4** SHEET: 4 OF 4

# SITE VOLUME CALCULATIONS

"ALL VOLUMES ARE APPROXIMATE AND REPRESENT FINISH GRADE TO EXISTING GRADE AS SHOWN. THE VOLUMES DO NOT INCLUDE STRIPPING, STRUCTURAL EXCAVATION, EXPANSION FACTOR OR ANY SOIL TYPE RESTRICTIONS".
